Technical product information

Topic	Vehicle vibration / humming at idle - Active engine mount leak - Active engine mount replacement
Market area	Russische Föderation (5RU),Australia E04 Bentley rest Asia and Australia (6E04),China 796 VW Import Comp. Ltd (Vico), Beijing (6796),Germany E02 Bentley rest Europe (6E02),Japan E03 Bentley Japan (6E03),Korea, (South) E08 Bentley South Korea (6E08),United Arab Emirates E06 Bentley Middle East and Africa (6E06),United Kingdom E01 Bentley UK (6E01),United States E05 Bentley USA and rest America (6E05)
Brand	Bentley
Transaction No.	2060418/1
Level	EH
Status	Approval
Release date

Vehicle vibration / humming noise at idle

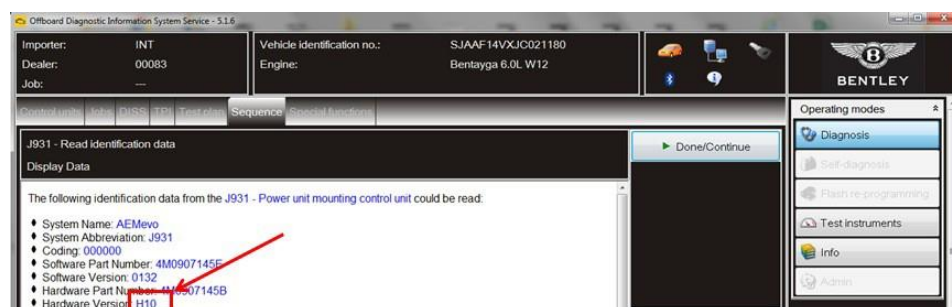
Figure 2 shows the Hardware version number at H10

- Should the Hardware version number not be H10, you must replace the AEM control module with part number 4M0 907 145

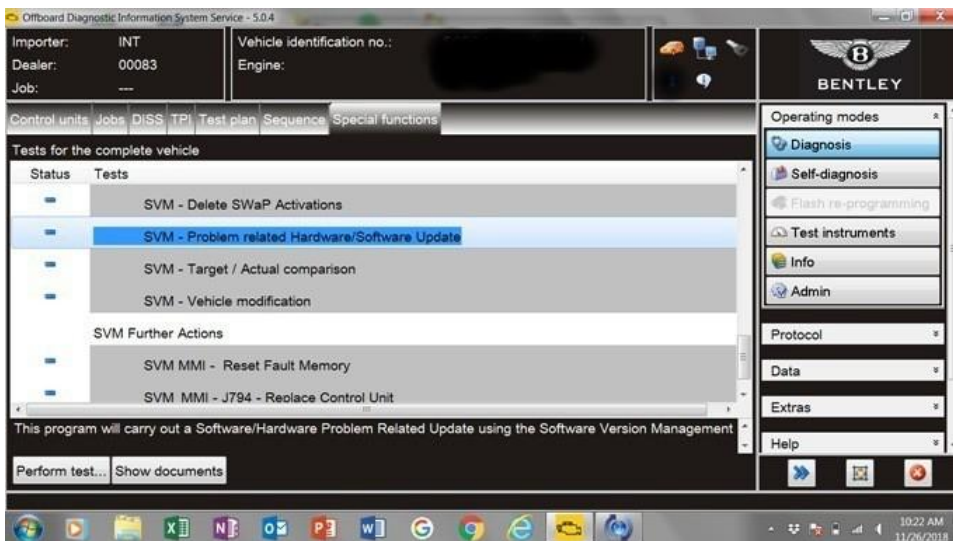
Figure 3

- Within the Special functions tab select SVM – Problem related Hardware/Software update then select Perform test (Figure 3).

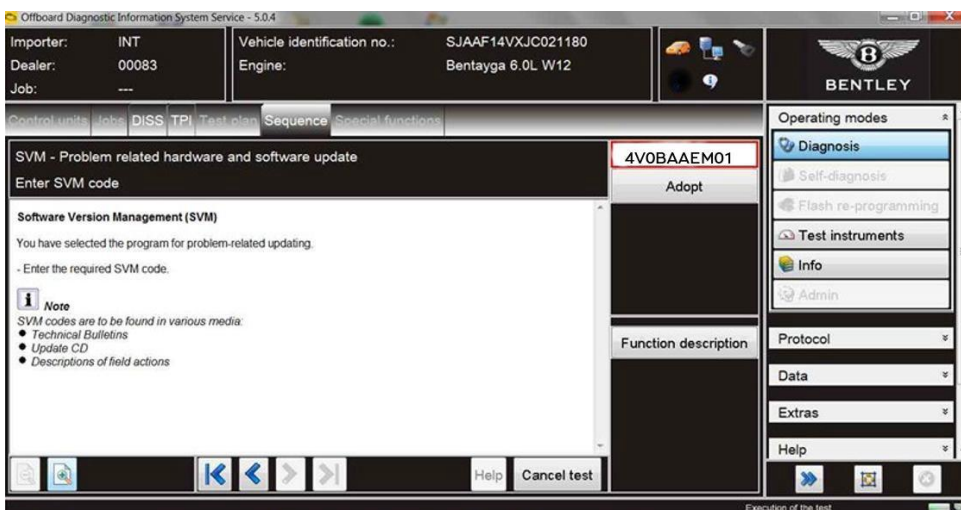
Figure 4

2. On the next screen enter the SVM code 4V0BAAEM01 and select Adopt (Figure 4).

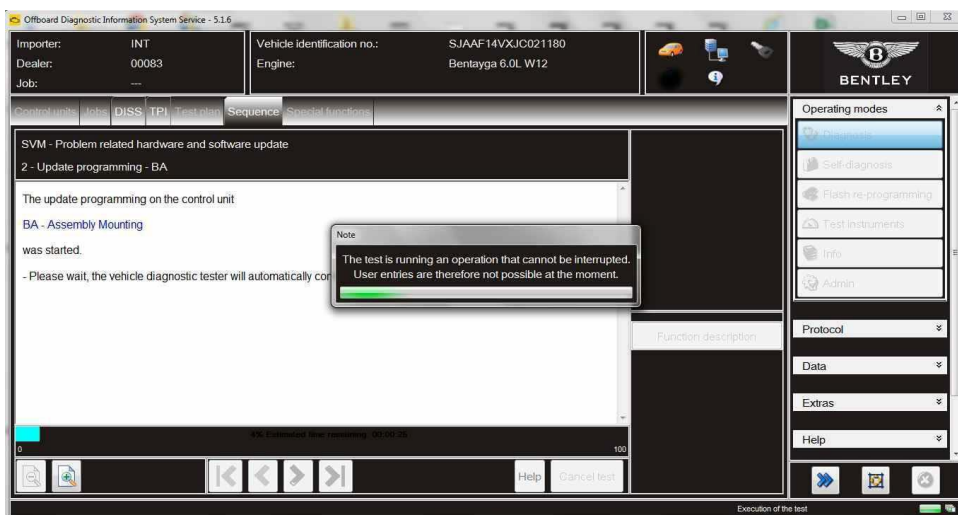
Figure 5

5. The software of 00BA Assembly Mounting will now be reprogrammed (Figure 5). NOTE: Depending on the software part number of the control module your vehicle may skip straight to step 6, if so proceed as instructed.

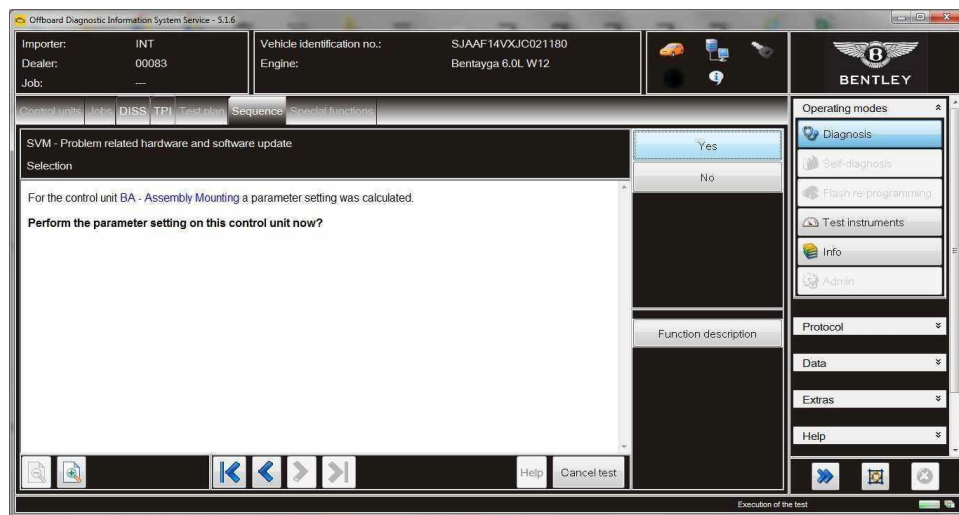
Figure 6

6. Once the software is updated, a parameter setting is required, select Yes (Figure 6).

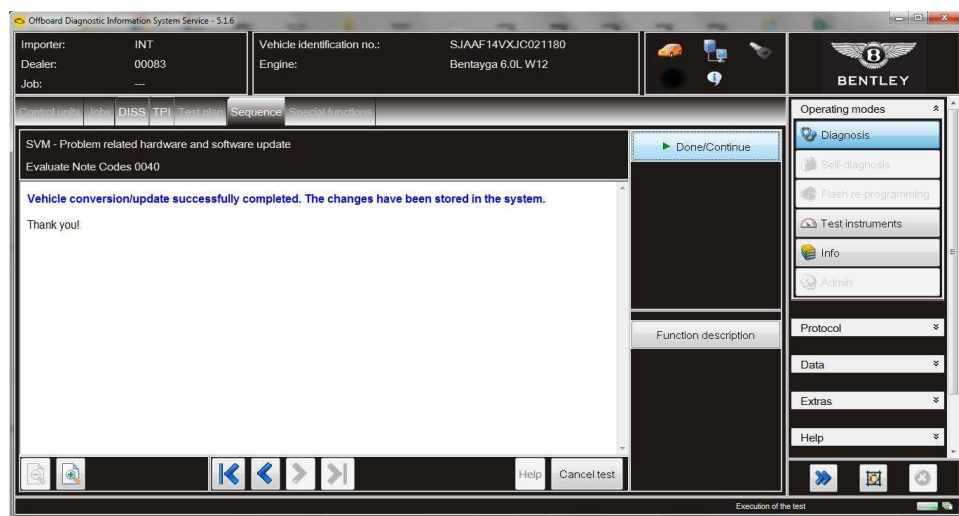
Figure 7

7. You will then see a confirmation message that the reprogramming has been successful (Figure 7).

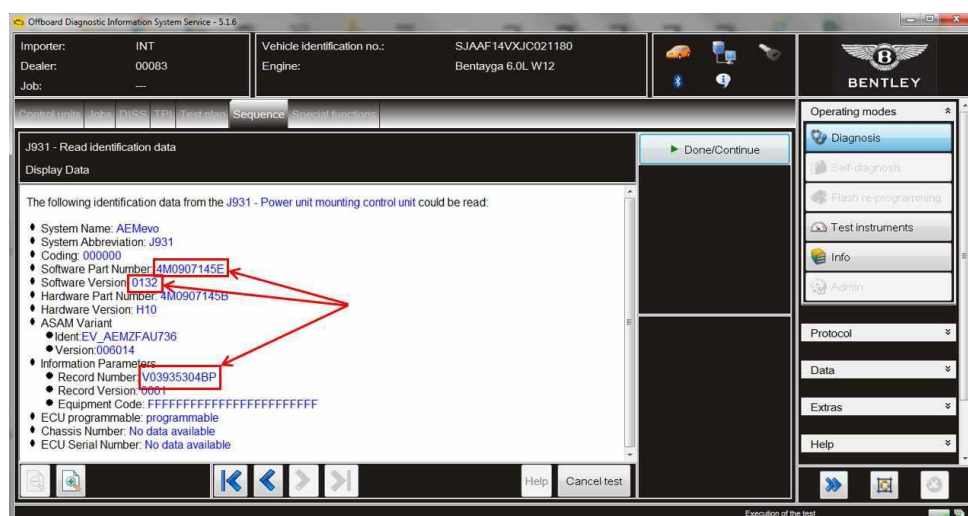
Figure 8

9. Confirm that the software reprogramming has completed successfully. Read the identification data of address 00BA (Figure 8).

Software Part Number	Software version	Record Number
4M0907145E	0132	V03935304BP
